### **QUERIES OF THE MONTH**

### AN EXHAUSTING TIME

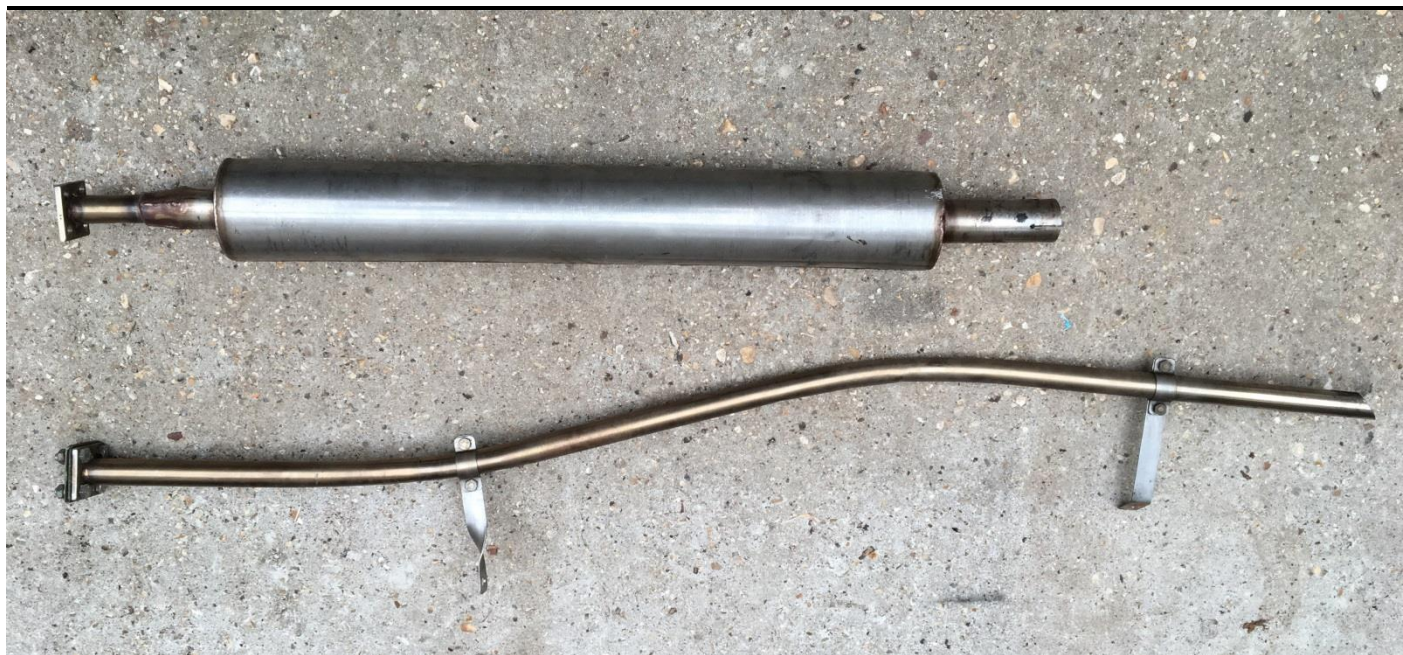
Well the only item I had not looked at was the exhaust system, but I had my suspicions. The tail pipe appeared to be of a smaller diameter than normal. The exhaust system, like everything else on the car, was very well engineered and manufactured by Dave's Dad. It was all stainless steel with flanged joints with stainless steel hangers (it would put a Rolls Royce to shame!).

Well, Do and I were due a visit from Trevor and Jean Edwards and the plan was, due to Covid 19 restrictions, that we would use two Austin 10/4, one each, for our trips out. So not wanting to be Tail End Charlie on our planned runs I decided to sort out the exhaust system. The existing stainless steel tail pipe has an internal diameter of 7/8". I had a rummage in the workshop and found an old Morris Minor tail pipe with an internal diameter of 1 1/4", although a different shape, with some cutting and welding a similar shaped tail pipe was produced. However, due to the flange joints on the stainless system, the existing silencer could not be used. Further rummaging found an old Austin 10 silencer complete with a large rusty hole; this was patched with a baked bean tin and a couple of Jubilee clips. Existing stainless steel system removed from the front pipe back. Then using some temporary hangers the bodged system was fitted. A road test revealed an increase in performance and lack of back firing on the over-run.

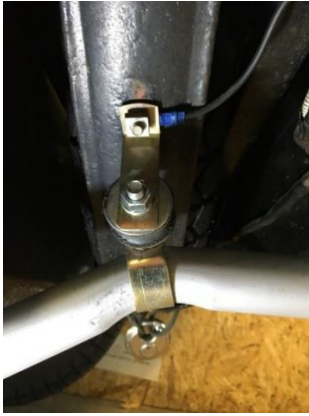
With these improvements a new silencer and tail pipe (1 1/4" diameter) were duly ordered from the ATDC spares department. As part of the fitting I decided to modify all the exhaust hangers. The original design for the 1933 Austin 10 results in the exhaust system being fixed directly to the chassis with no flexible damping whatsoever. So I manufactured new hangers and mounts using rubber resilient mounts in all positions. Below are two of the mounts.
